INDOOR AIR QUALITY ASSESSMENT

Butler Middle School 1140 Gorham Street Lowell, Massachusetts

Prepared by: Massachusetts Department of Public Health Bureau of Environmental Health Assessment August, 2000

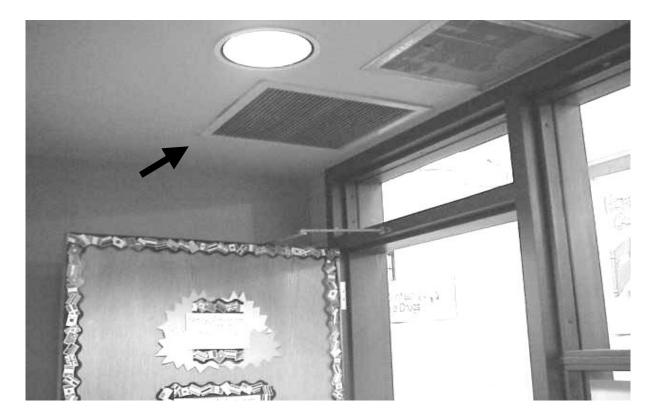
In some classrooms, the exhaust vent is located above the classroom door. The location of these exhaust vents can limit exhaust efficiency when the classroom door is open (see Picture 2). When a classroom door is open, exhaust vents will tend to draw air from both the hallway and the classroom. The open hallway door reduces the effectiveness of the exhaust vent to remove common environmental pollutants from classrooms. Without removal by the exhaust vents, these normally occurring environmental pollutants can build up and lead to indoor air quality and comfort complaints.

Ceiling-Mounted Exhaust Vent in Classroom: Note Open Classroom Door to Hallway

- 5. Inspect exhaust motors and belts for proper function, repair and replace as necessary. Close classroom doors to maximize exhaust ventilation. Examine exhaust ventilation in art room (201) to determine function.

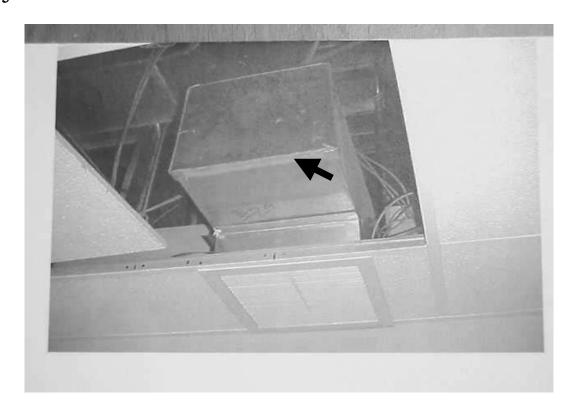
Complaints of stuffiness were reported by occupants in art room 201. The exhaust system in this area was not functioning at the time of the assessment. BEHA staff removed tiles to observe conditions in the ceiling plenum. It appears that the exhaust vent was sealed or was not connected to the ductwork (see Picture 3). Without

Sealed Exhaust Vent in Art Room

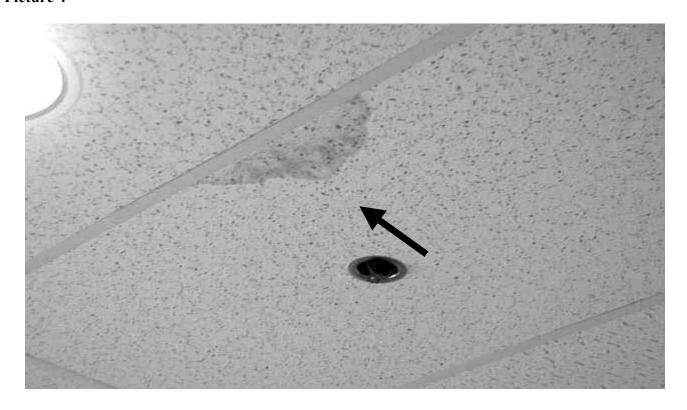
Mold growth was reported on pipe insulation above the ceiling tiles in several areas of the school. The insulation had been replaced on the pipes in these areas prior to the 1999-2000 school year. School staff reported that many water-damaged ceiling tiles were replaced during the remediation efforts. First floor classrooms have ceiling tiles that were reportedly water-damaged since the summer remediation (see Picture 4). Uninsulated pipes, supporters and hangers in the ceiling plenum were corroded with rust, which would indicate chronic exposure to moisture (see Picture 5). From these conditions, it is clear that moisture was introduced into the building resulting in condensate on metal fixtures above the ceiling tiles.

Water-Stained Ceiling Tile in Classroom

- 11. Replace any remaining water-stained ceiling tiles, wall board and pipe insulation.

Examine the areas above and around these areas for mold growth. Repair water leaks and disinfect areas of water leakage with an appropriate antimicrobial if necessary.
- 12. Seal areas around sink in classroom 239, to prevent water-damage to the interior of cabinets and adjacent wallboard. Inspect wallboard for water-damage and

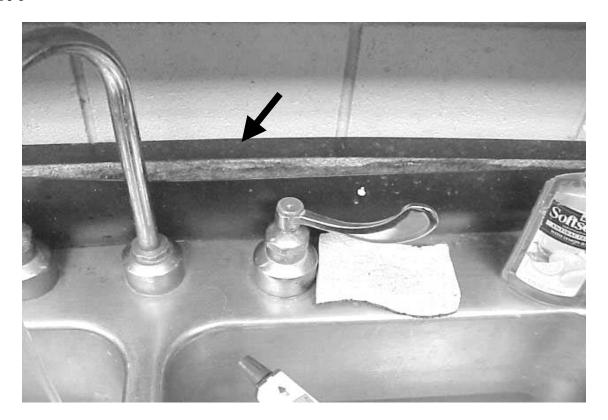
Room 110 had curled/buckled laminated countertops due to moisture penetration. Spaces between the sink countertop and backsplash (see Picture 6) in the home economics room 239 were also noted. Improper drainage or overflow could lead to water penetration of countertop wood, the cabinet interior and behind cabinets. Like other porous materials, if these materials become wet repeatedly it can provide a medium for mold growth, which is difficult to clean and make them irritating to sensitive individuals.

Water Damage to Sink Backsplash

- mold/mildew growth, repair/replace as necessary. Disinfect areas of microbial growth with an appropriate antimicrobial as needed.
- 13. Store flammable materials in flameproof cabinets in a manner consistent with state and local fire codes.

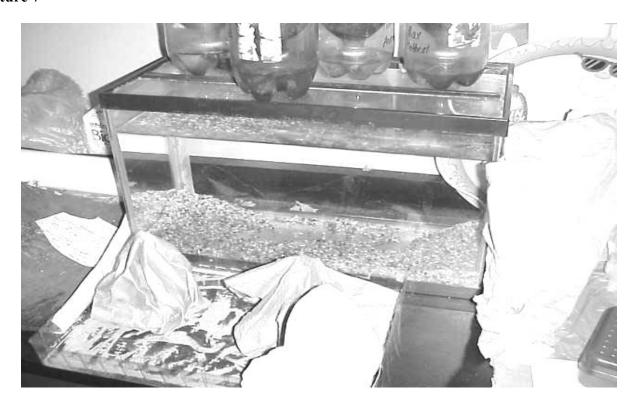
Room 237 contained an aquarium with standing water (see Picture 7). Standing water can lead to algae/mold/bacterial growth. These growths can be a source of foul odors and can be irritating to some individuals. Regular maintenance and treatment of

Aquarium with Standing Water in Classroom 237

- 18. Refrain from using strong scented materials in classrooms and restrooms.
- 19. Ensure aquariums are properly cleaned to prevent odors and/or algae growth.

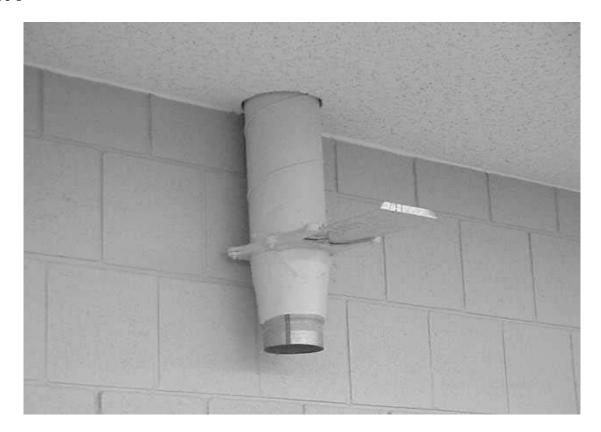
ductwork. It was reported to BEHA staff that several of the ducts to the wood dust collection system were disconnected due to excessive clogging by wood dust (see Picture 8). In addition, the wood dust collector contains a filter, which was also clogged with accumulated materials (see Picture 9). Wood duct filters should be changed as per the manufacturer's instructions, or more frequently if needed, to avoid the build up and reaerosolization of wood dust and particulate matter.

Disconnected Ductwork for Wood Dust Collector (reportedly disconnected due to clogging)

- 15. Restore wood dust collection system to proper function. Clean/replace filter for wood dust collector as recommended by the manufacturer or more frequently if needed.

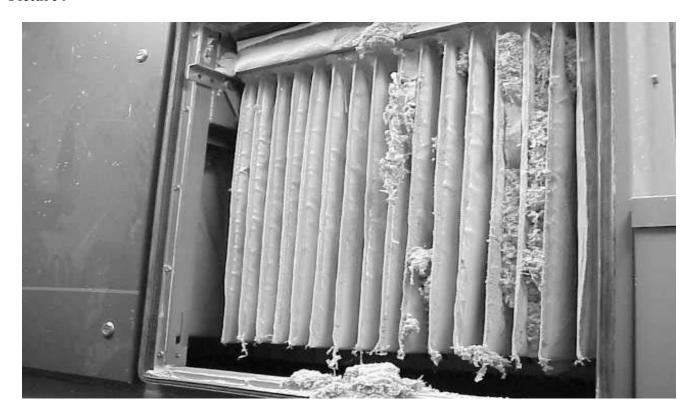
Accumulated Wood Dust in Wood Dust Collector Filter

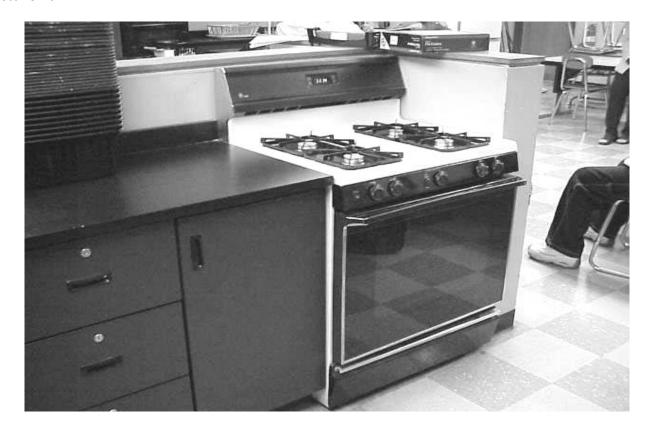
The home economics room (239) contained a gas stove without a local exhaust hood (see Picture 10). Without local exhaust ventilation, combustion by-products (e.g., carbon monoxide) as well as grease, moisture and cooking odors can buildup in the room.

Unventilated Gas Stove in Home Economics Area

- 20. Examine the feasibility of providing local exhaust ventilation for gas stoves.
- 21. Reactivate exhaust ventilation in elevator to remove excess heat, odors and moisture generated by occupants.

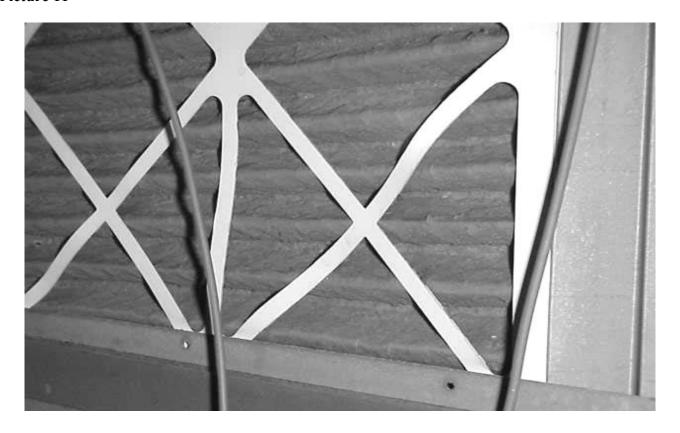
BEHA staff examined the interior of HVAC unit #3, located in the second floor mechanical room. The filters of HVAC-3 were coated with dirt/dust and accumulated material (see Picture 11). This condition obstructs airflow through the filters, and may serve to reaerosolize and distribute pollutants to occupied areas via the ventilation system.

Filter Saturated with dirt/dust accumulation in HVAC Unit # 3

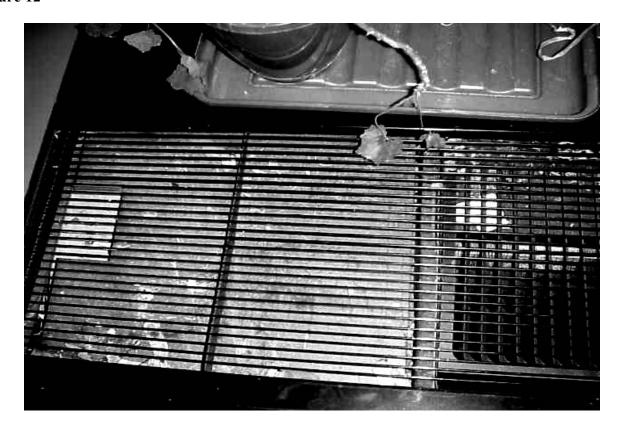
Accumulated dirt/dust/pottery debris was also noted within the univent. Clay dust is a fine particulate that can be easily aerosolized and distributed in the air stream from the univent diffuser. Accumulated dirt/dust/debris was also noted in several other classroom univents (see Picture 12).

Accumulated Debris in Univent

- 6. Remove all blockages from univents to ensure adequate airflow. Clean out interiors of univents.
- 7. Once both the fresh air supply and the exhaust ventilation are functioning properly, the system should be balanced by an HVAC engineer.
